Section 7 Results of Fieldwork

7.1 Results of Pedestrian Inspection

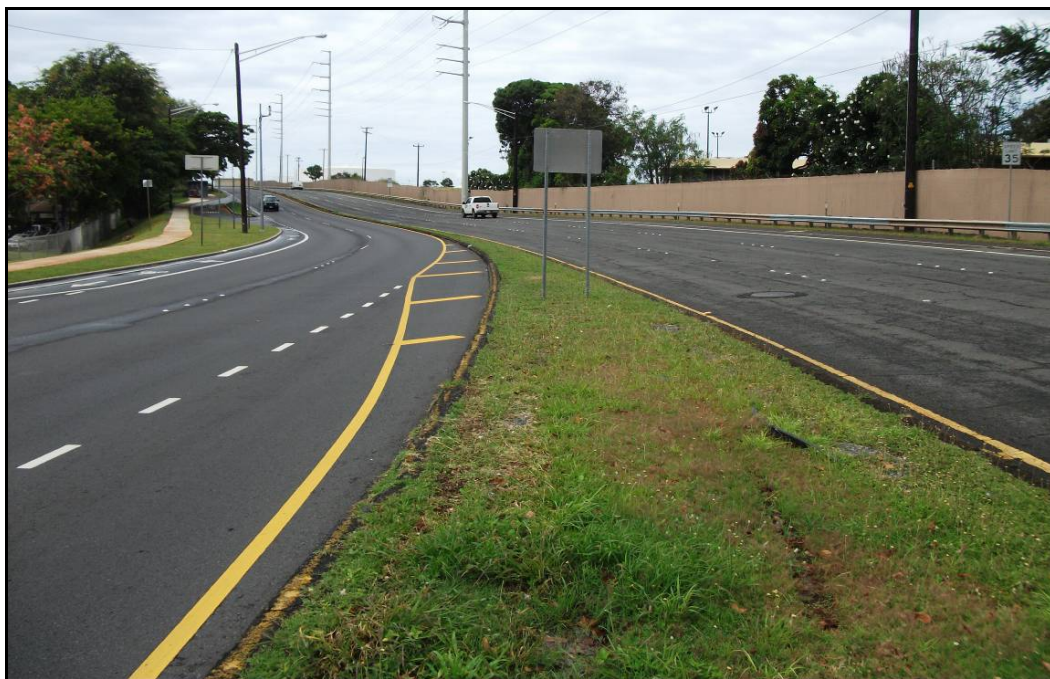
Figure 68. General view of T-004 (column foundation) vicinity in median of Kamehameha Highway, south of Hālawā Drive, view to south

Beginning at its northern extent, Figure 65 and Figure 66 show the recent road bridge, and landscaping work that characterize the area where Kamehameha Highway crosses Hālawā Stream just south of the intersection of Kamehameha Highway and Kalaloa Street/Arizona Memorial Place. Also present are areas where significant sculpturing of the land surface has occurred (Figure 67 and Figure 68).

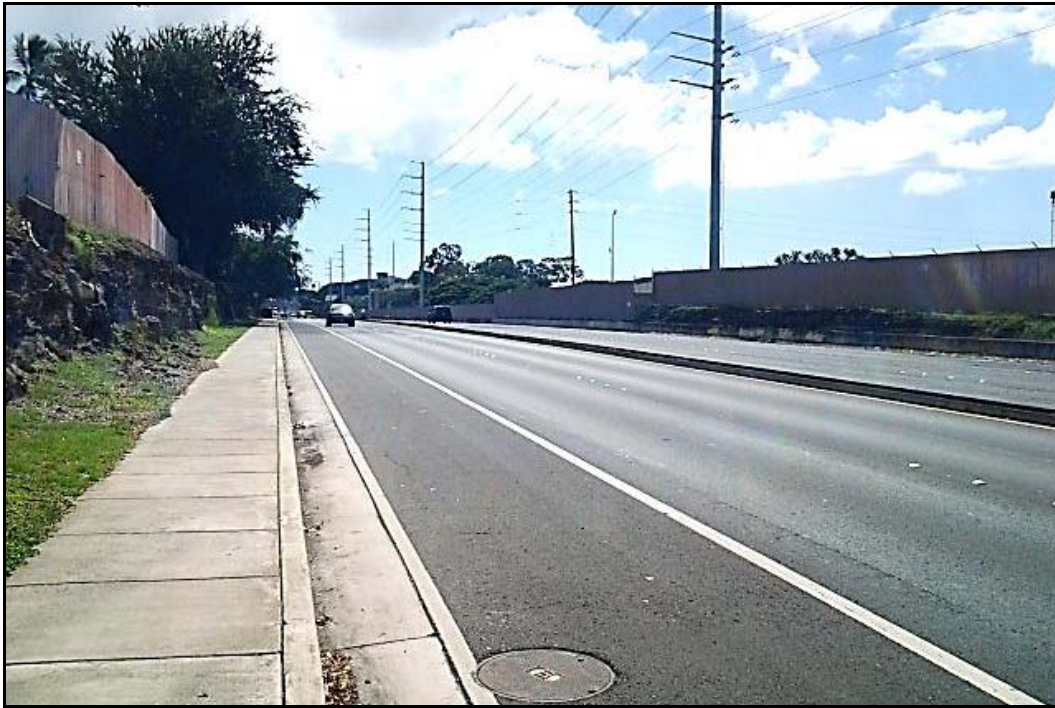
Figure 69. General view of T-005 (column foundation) vicinity showing volcanic tuff ridges on on both sides of Kamehameha Highway at base of fences, view to south

Figure 69 and Figure 70 show two significant fingers of rock land (RL) with little soil development bracketing a small swale of relatively fertile Hanalei silty clay in the immediate vicinity of Kamehameha Highway and Radford Drive (see Figure 5). The Pearl Harbor Naval Base Station lies within the silty clay area between the two ridges of rock land outcrop (Figure 71 and Figure 72).

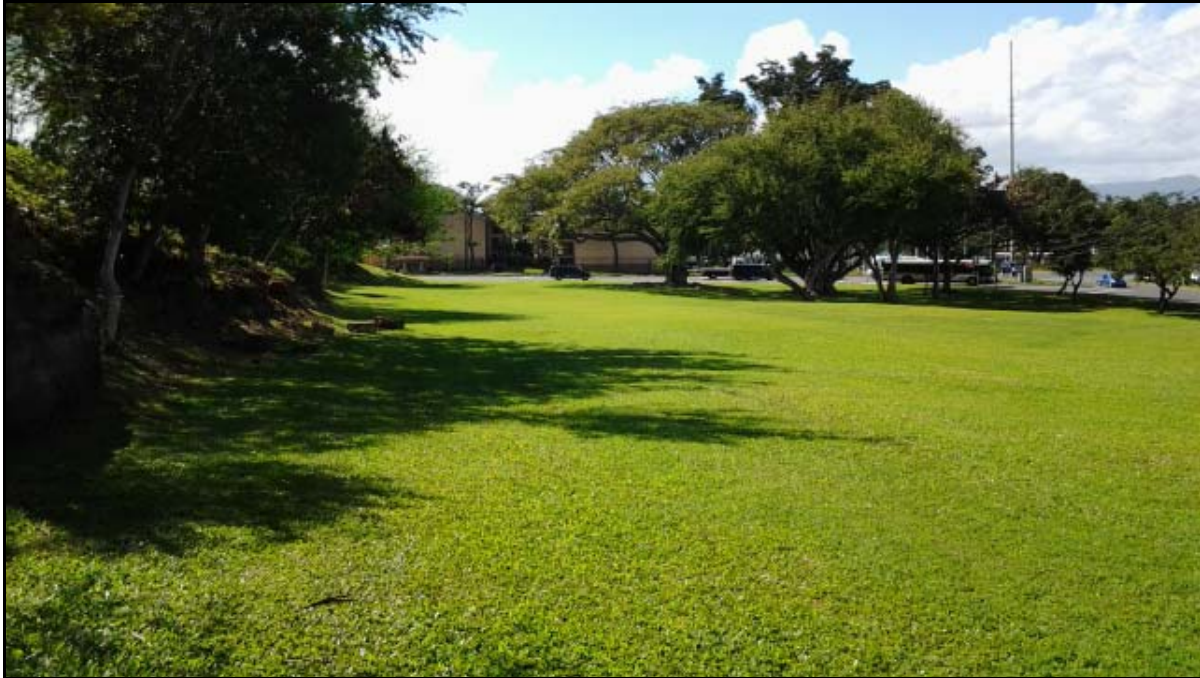
Figure 71. General view of Pearl Harbor Naval Base Station at the northeast corner of Kamehameha Highway (in background) and Radford Drive (at right), view to west

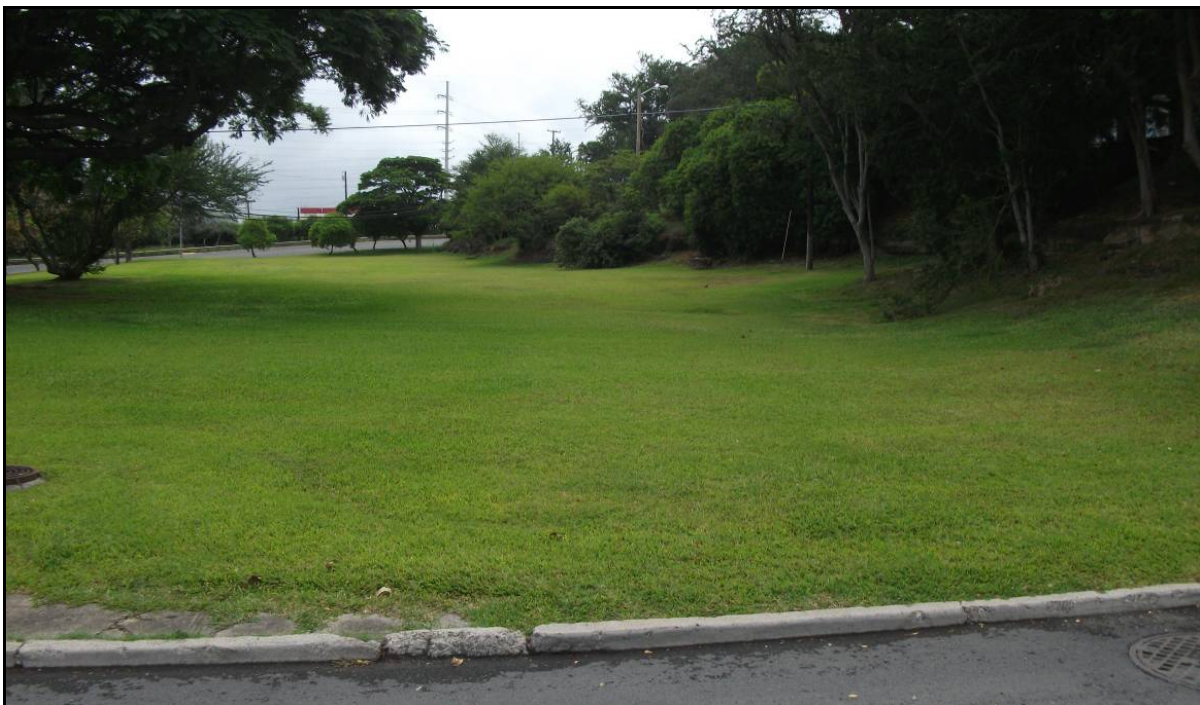
Figure 72. General view of Pearl Harbor Naval Base Station on the east side of Kamehameha Highway and just south of Radford Drive (arcing to the southeast in background), view to east

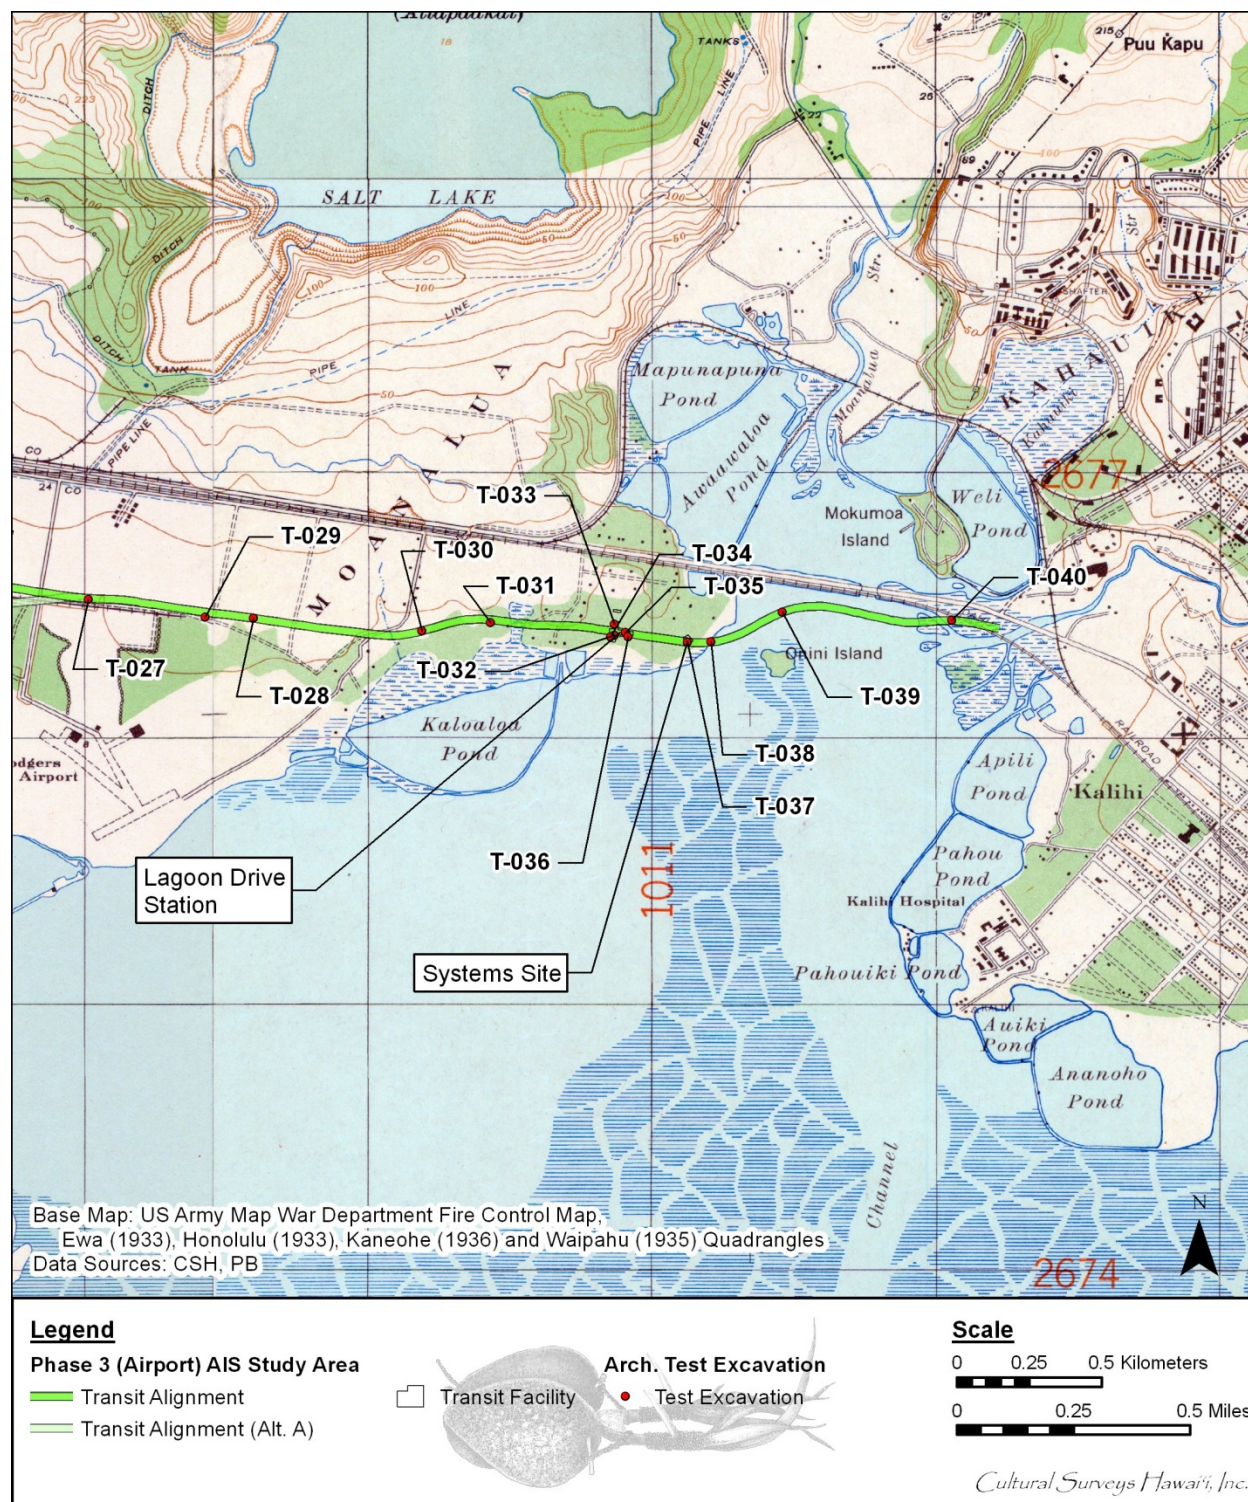
Figure 102. Overlay of east portion of Airport Section 3 test excavations (approximate location) on 1933 U.S. Army War Department Fire Control map

Forty-seven test excavations (T-001 through T-047) were investigated in the Airport Section 3 project area. An overview of the geographic distribution of these test excavations is provided in Figure 36 and Figure 37. A detailed discussion of each test excavation follows including reference to a location map, photographs of the excavation location and stratigraphy, an illustrated profile, a tabulated description of the stratigraphy, and a descriptive summary of the excavation conditions and results. Test excavation locations are cross-referenced to historic maps with an overlay depicting the approximate excavation location (Figure 94 through Figure 107).

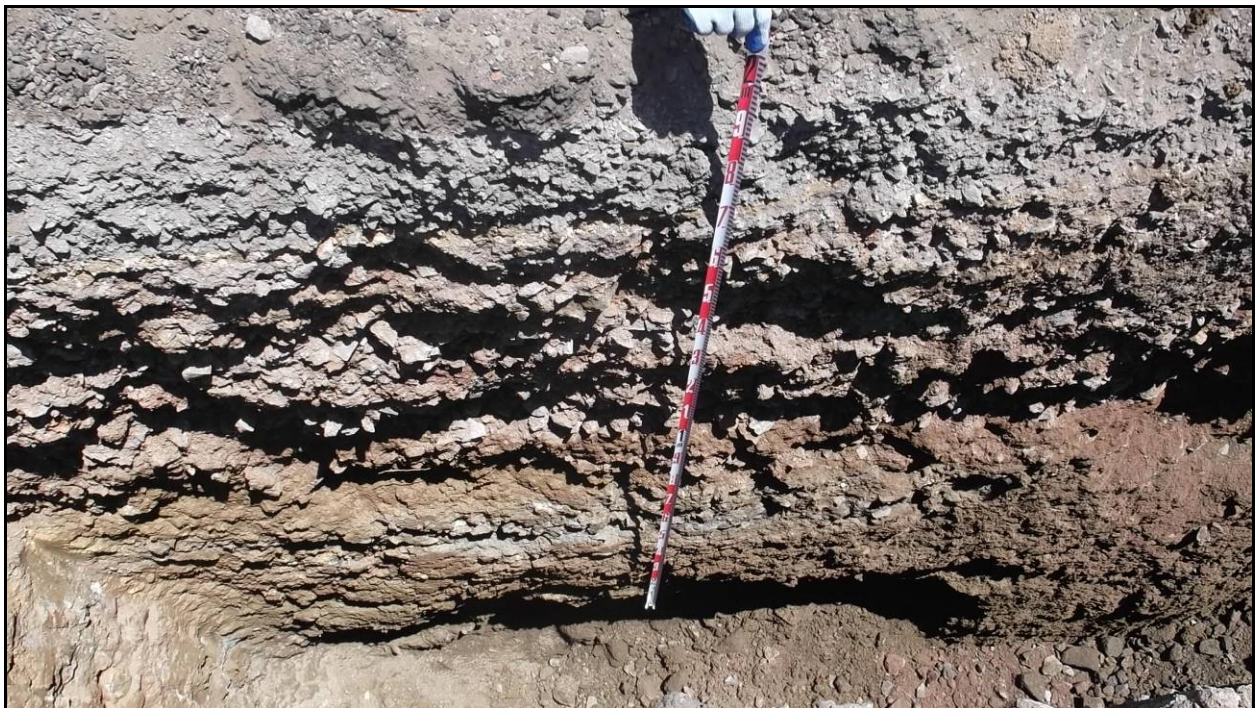
Figure 109. Photograph of Airport Section 3, T-001, general view of profile, view to east

Stratigraphic Summary: The stratigraphy of T-001 consisted of fill strata to the base of excavation (Figure 109 and Figure 110). Observed strata were asphalt (Stratum Ia), basalt gravel base course (Stratum Ib), crushed coral fill (Stratum Ic), extremely gravelly silt fill (Stratum Id), gravelly clay loam fill (Stratum Ie), very cobbly loam fill (Stratum If), and gravelly clay loam fill (Stratum Ig). The stratigraphy conformed to the USDA soil survey designation of Fill land (FL).

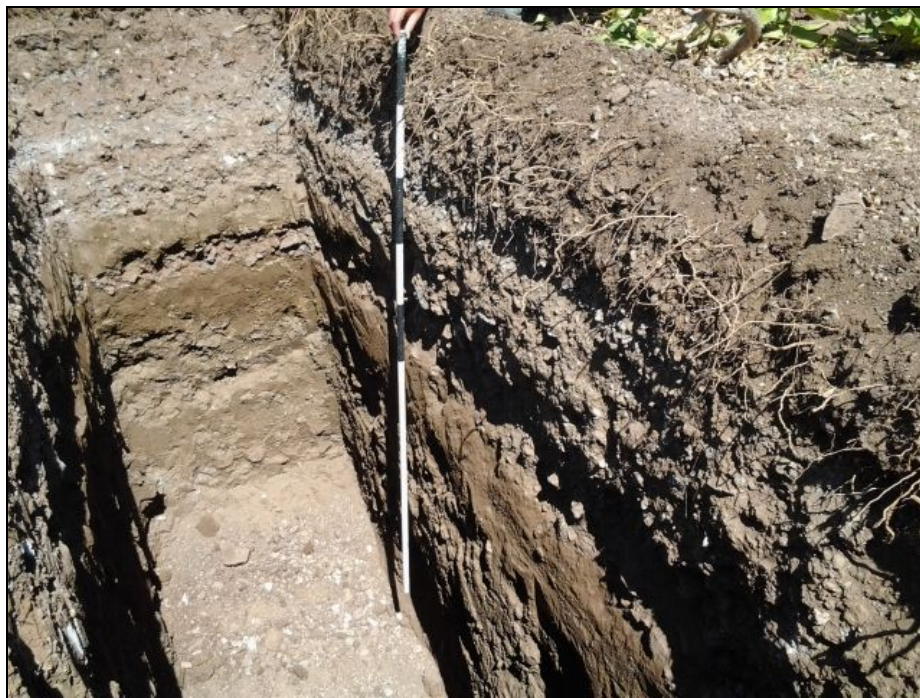
Figure 112. Photograph of Airport Section 3, T-002, general view of profile, view to southeast

Stratigraphic Summary: The stratigraphy of T-002 consisted of fill strata to the base of excavation (Figure 112 and Figure 113). Observed strata were imported sandy silt loam topsoil fill (Stratum Ia), coral gravel base course (Stratum Ib), extremely gravelly clay fill (Stratum Ic), and locally-procured clay fill (Stratum Id) overlying basalt bedrock. A concrete cylinder and concrete slab fragments were observed within Stratum Id between 2.10 mbs and 2.40 mbs. The stratigraphy conformed to the USDA soil survey designation of Fill land (FL).

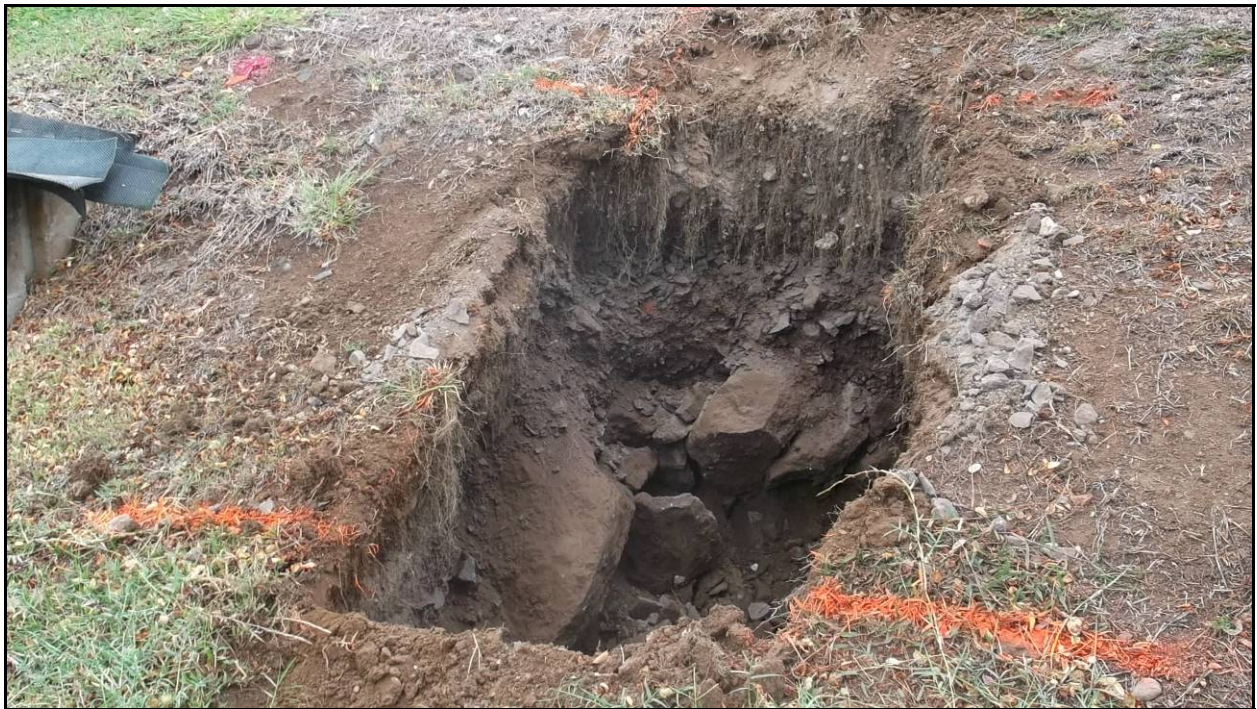
Figure 115. Photograph of Airport Section 3, T-003, general view of profile, view to west

Stratigraphic Summary: The stratigraphy of T-003 consisted of fill strata over natural sediment (Figure 115 and Figure 116). Observed strata were imported topsoil fill (Stratum Ia), gravelly sandy silt fill (Stratum Ib), extremely gravelly sand fill (Stratum Ic), and extremely stony sand fill (Stratum Id) overlying natural clay loam with basalt boulders (Stratum II), and natural clay loam with decomposing coral and a marine shell (Stratum III). The stratigraphy generally conformed to the USDA soil survey designation of Fill land (FL).

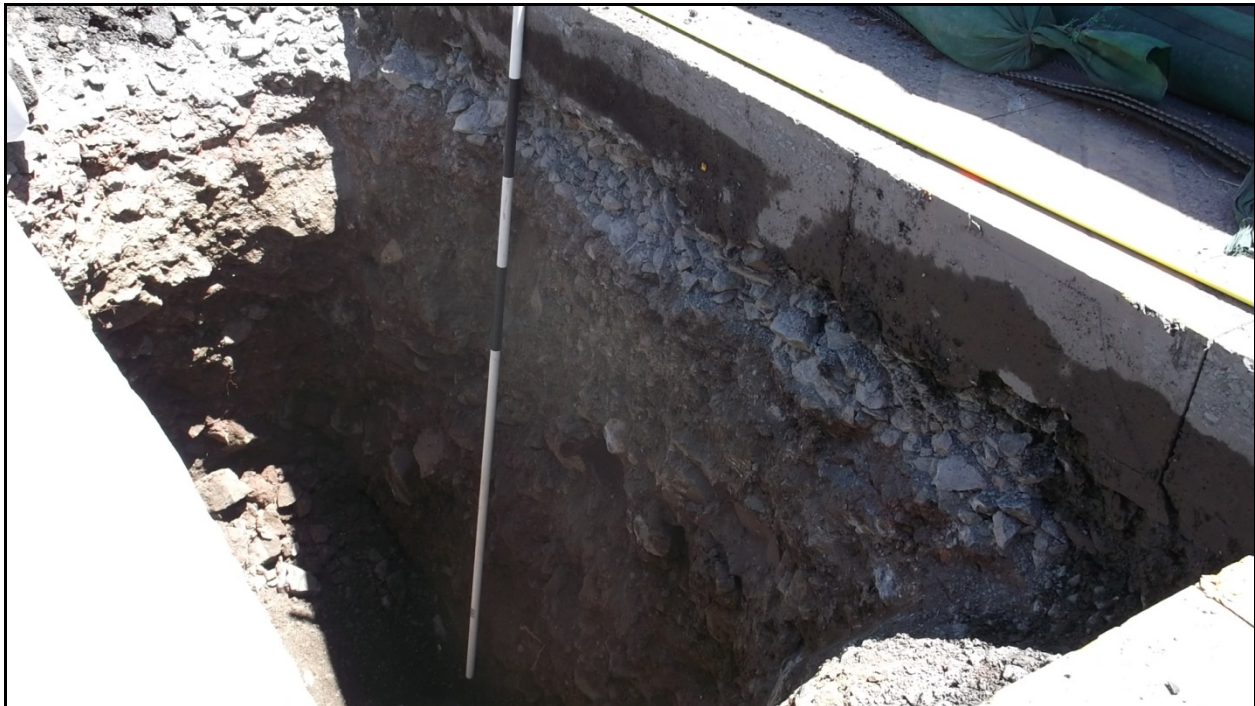
Figure 118. Photograph of Airport Section 3, T-004, general view of profile, view to northeast

Stratigraphic Summary: The stratigraphy of T-004 consisted of fill over bedrock at the base of excavation (Figure 118 and Figure 119). Observed strata were asphalt (Stratum Ia), basalt gravel base course (Stratum Ib), and very gravelly loam fill (Stratum Ic) overlying natural basalt bedrock (Stratum II). The stratigraphy conformed to the USDA soil survey designation of Fill land (FL).

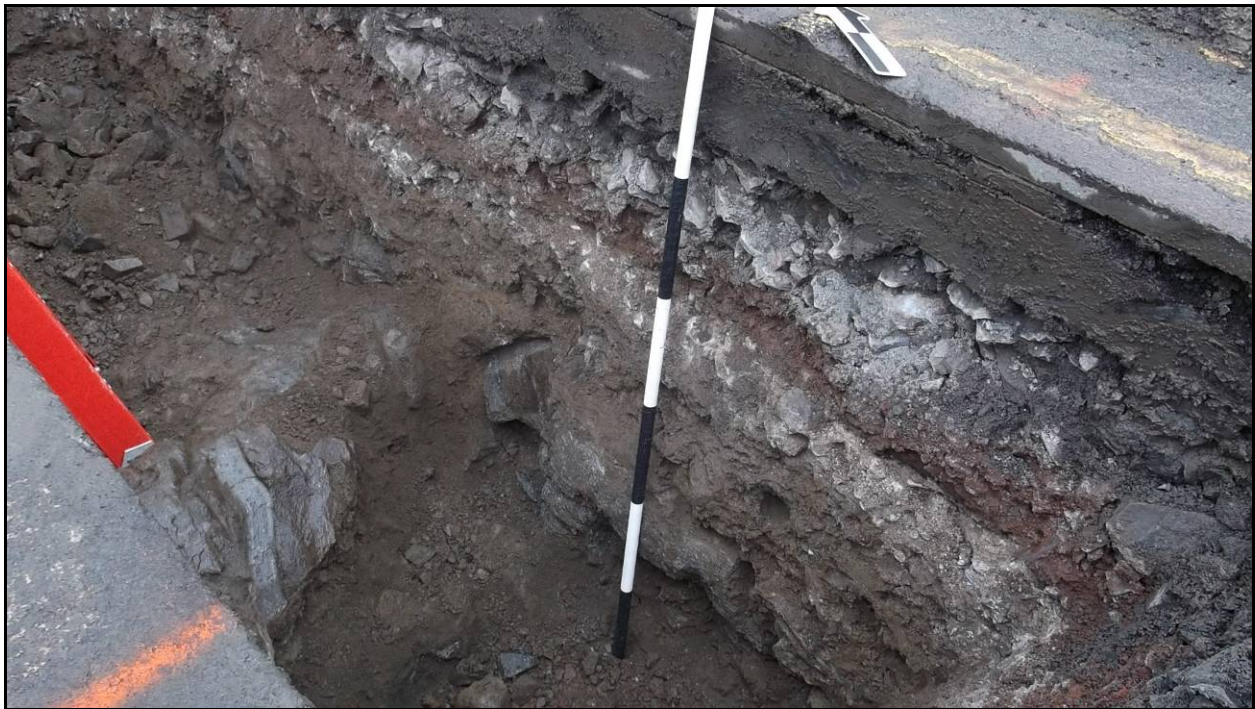
Figure 121. Photograph of Airport Section 3, T-005, general view of profile, view to northeast

Stratigraphic Summary: The stratigraphy of T-005 consisted of several fill strata overlying natural sediment and volcanic tuff bedrock (Figure 121 and Figure 122). Observed strata were asphalt (Stratum Ia), basalt gravel base course (Stratum Ib), gravelly clay loam fill (Stratum Ic), and very gravelly sand fill (Stratum Id), overlying natural extremely gravelly loam (Stratum II) and volcanic tuff bedrock (Stratum III). The stratigraphy conformed to the USDA soil survey designation of Kokokahi very stony clay (KTKE).

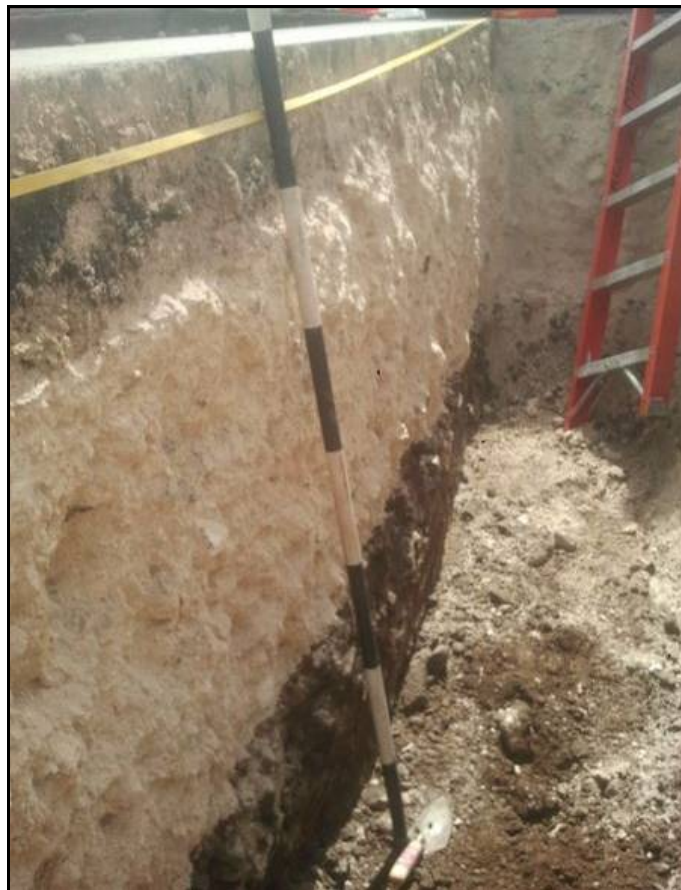
Figure 124. Photograph of Airport Section 3, T-006, general view of profile, view to southeast

Stratigraphic Summary: The stratigraphy consisted of fill strata over natural sediment (Figure 124 and Figure 125). Observed strata were asphalt (Stratum Ia), very gravelly to cobbly crushed coral fill (Stratum Ib), and natural very cobbly clay loam (Stratum II). The large quantity of water-rounded basalt cobbles within the upper and lower boundaries of Stratum II may be indicative of high energy alluvial deposition. The stratigraphy generally conformed to the USDA soil survey designation of Fill land (FL).

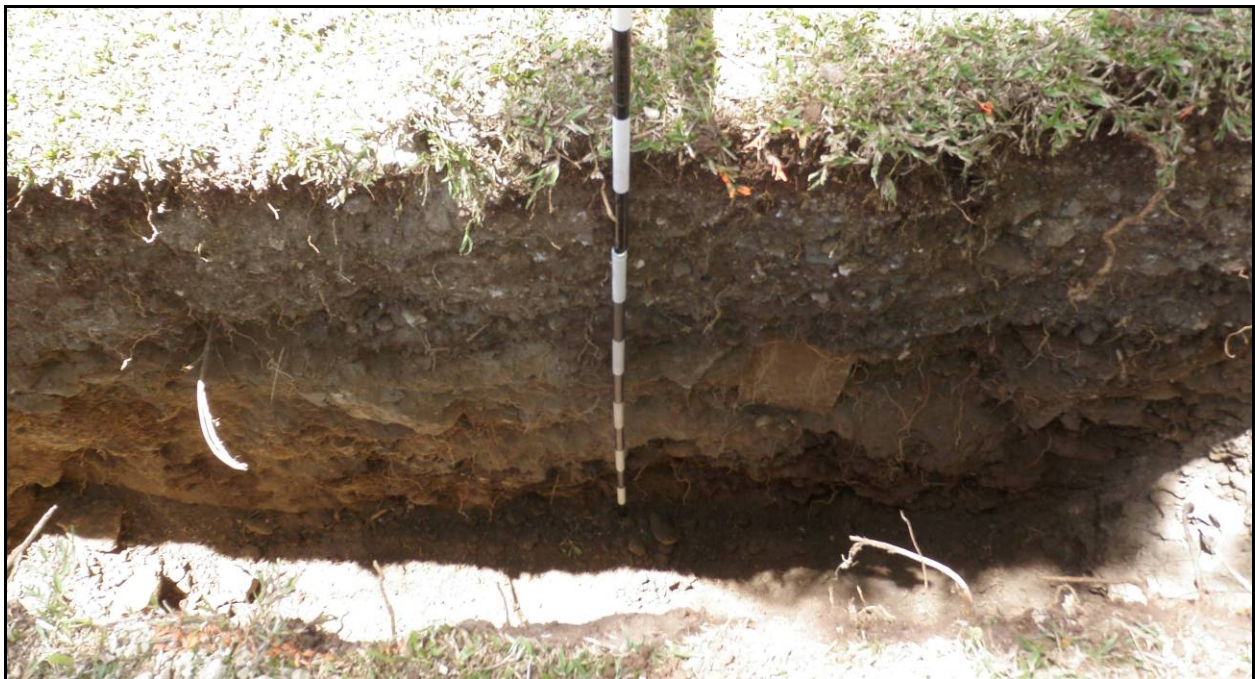
Figure 128. T-007 northwest profile, view to northwest

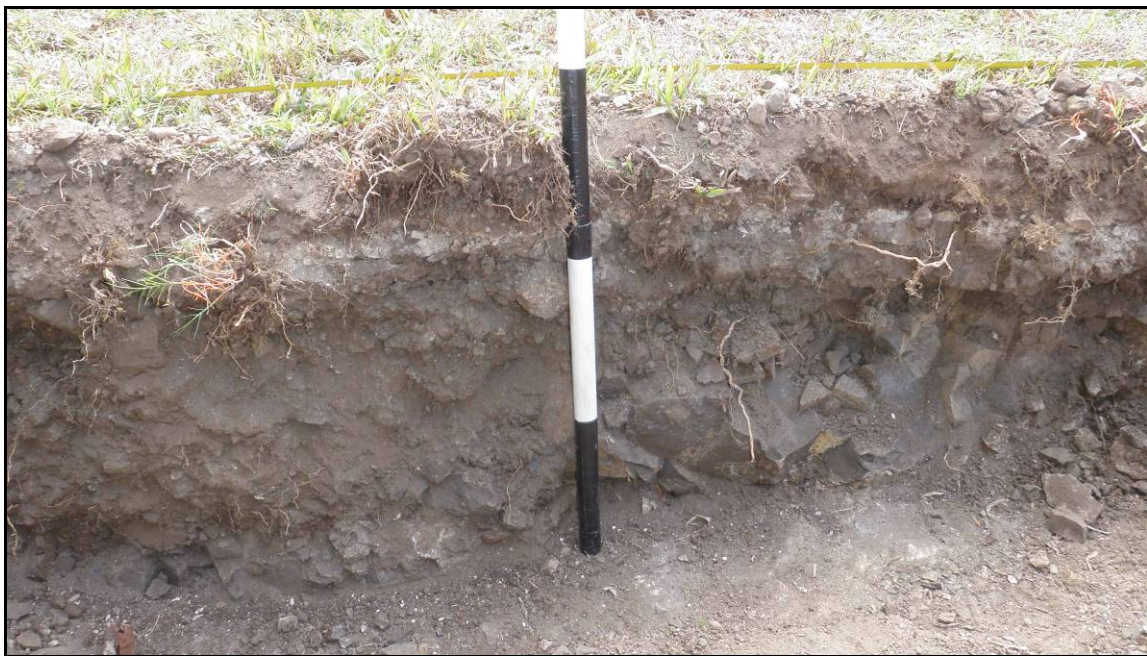
Stratigraphic Summary: The stratigraphy of T-008 consisted of fill overlying bedrock (Figure 131 and Figure 132). Observed strata were topsoil (Stratum Ia) and sand fill (Stratum Ib), overlying naturally-decomposing basalt bedrock (Stratum IIa) that graded into solid basalt bedrock (Stratum IIb). The stratigraphy conformed to the USDA soil survey designation of Rock land (rRk).

Figure 131. Photograph of Airport Section 3, T-008 east profile, view to east

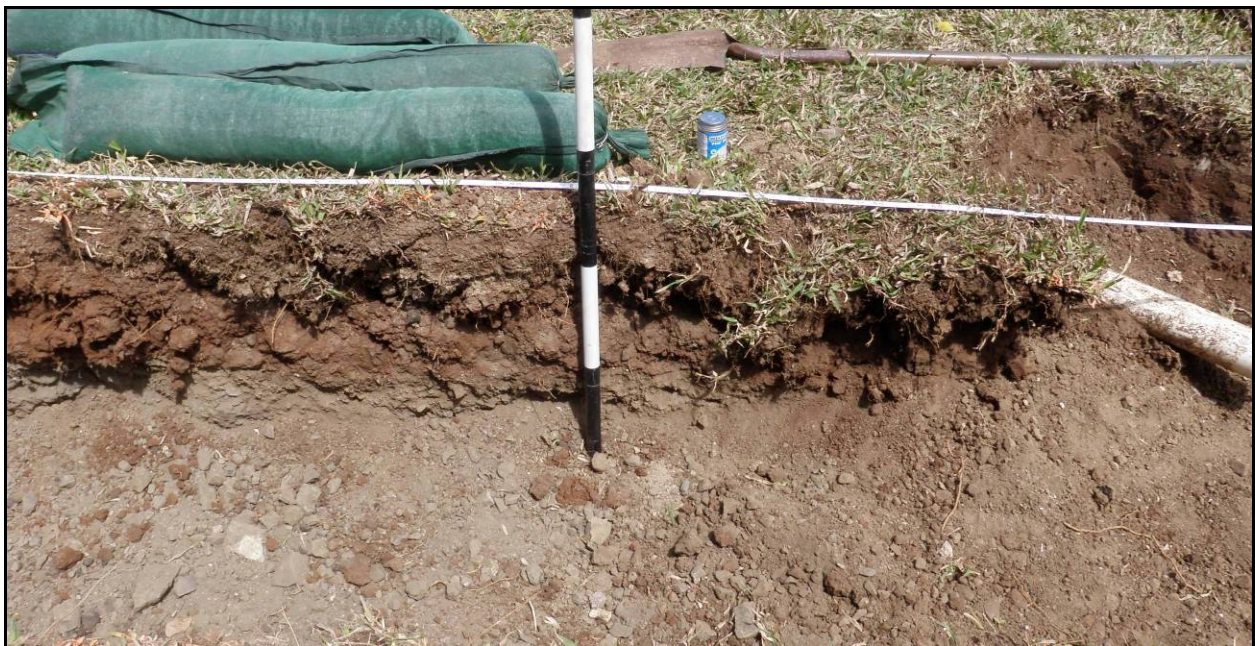
Stratigraphic Summary: The stratigraphy consisted of fill over bedrock (Figure 134 and Figure 135). Observed strata were sod with grass (Stratum Ia) and imported clay loam fill (Stratum Ib) overlying decomposing bedrock (Stratum II). The bedrock was formed from volcanic tuff deposits from the Makalapa and/or Āliamanu events. The stratigraphy conformed to the USDA soil survey designation of Rock land (rRk).

Figure 134. Photograph of Airport Section 3, T-009, view to northwest

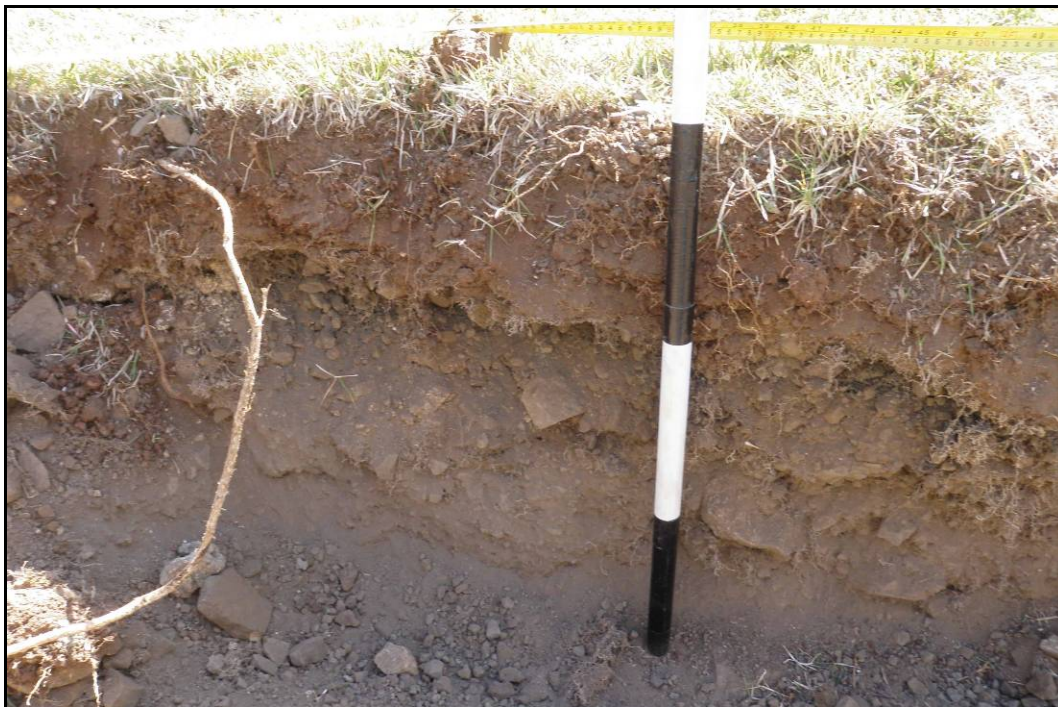
Stratigraphic Summary: The stratigraphy of T-010 consisted of topsoil over natural sediment (Figure 137 and Figure 138). Observed strata were topsoil (Stratum I), natural extremely gravelly sand with sparse cultural material (Stratum II), and volcanic tuff bedrock (Stratum III). Stratum II was considered to be a possible remnant former land surface (A-horizon) that was horizontally truncated and leveled. Stratum III (bedrock) was formed from volcanic tuff deposits from the Makalapa and/or Āliamanu events. The stratigraphy conformed to the USDA soil survey designation of Rock land (rRK).

Figure 137. Photograph of Airport Section 3, T-010, east wall profile, view to east

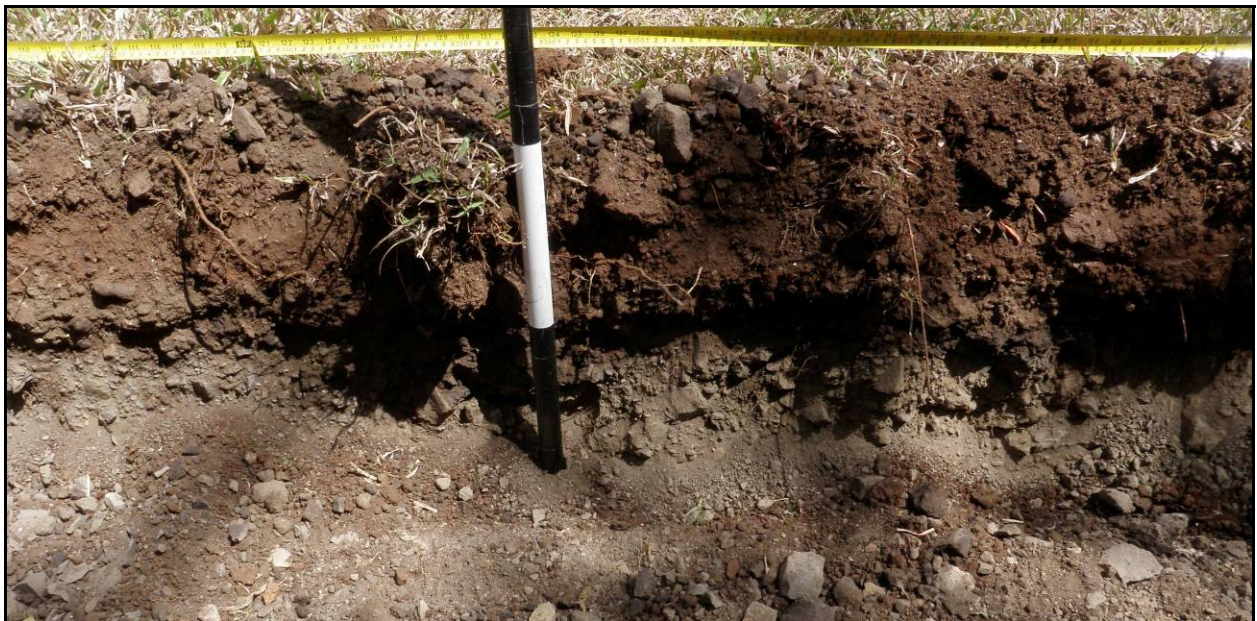
Stratigraphic Summary: The stratigraphy of T-011 consisted of topsoil over natural sediment (Figure 140 and Figure 141). Observed strata were imported topsoil fill (Stratum I) overlying natural extremely gravelly silt (Stratum II) and volcanic tuff bedrock (Stratum III). Stratum II is considered to be a possible former land surface (A-horizon) that has been truncated horizontally and leveled. Stratum III was formed from volcanic tuff from the Makalapa and/or Āliamanu events. The stratigraphy conformed to the USDA soil survey designation of Rock land (rRK).

Figure 140. Photograph of Airport Section 3, T-011, north wall profile, view to north

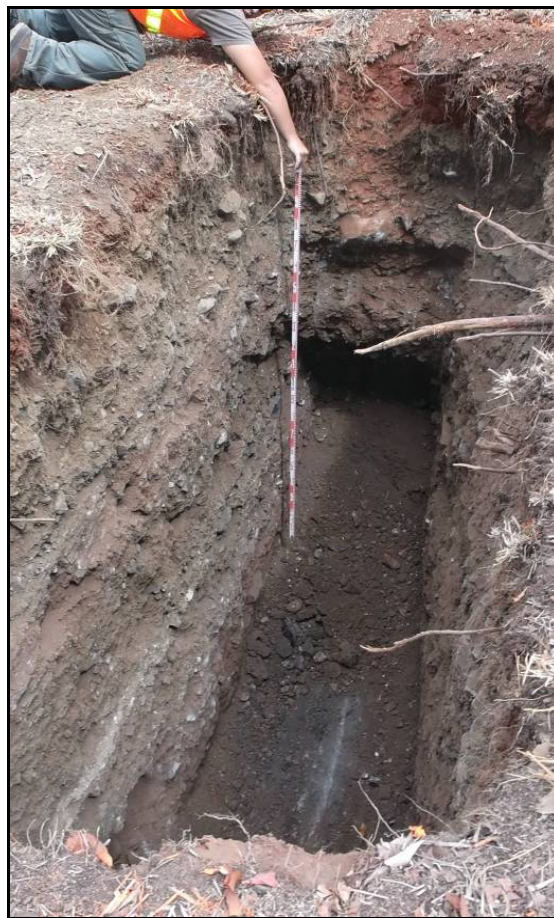
Feature Discussion: One feature, designated as SIHP # 50-80-13-7420 Feature 1, was encountered within T-015, at the base of excavation and extending beyond the boundaries of the excavation area. Feature 1 was interpreted as a historic asphalt pavement possibly associated with an early road alignment pre-dating Kamehameha Highway.

Figure 152. Photograph of Airport Section 3, T-015, general view of profile, view to northwest

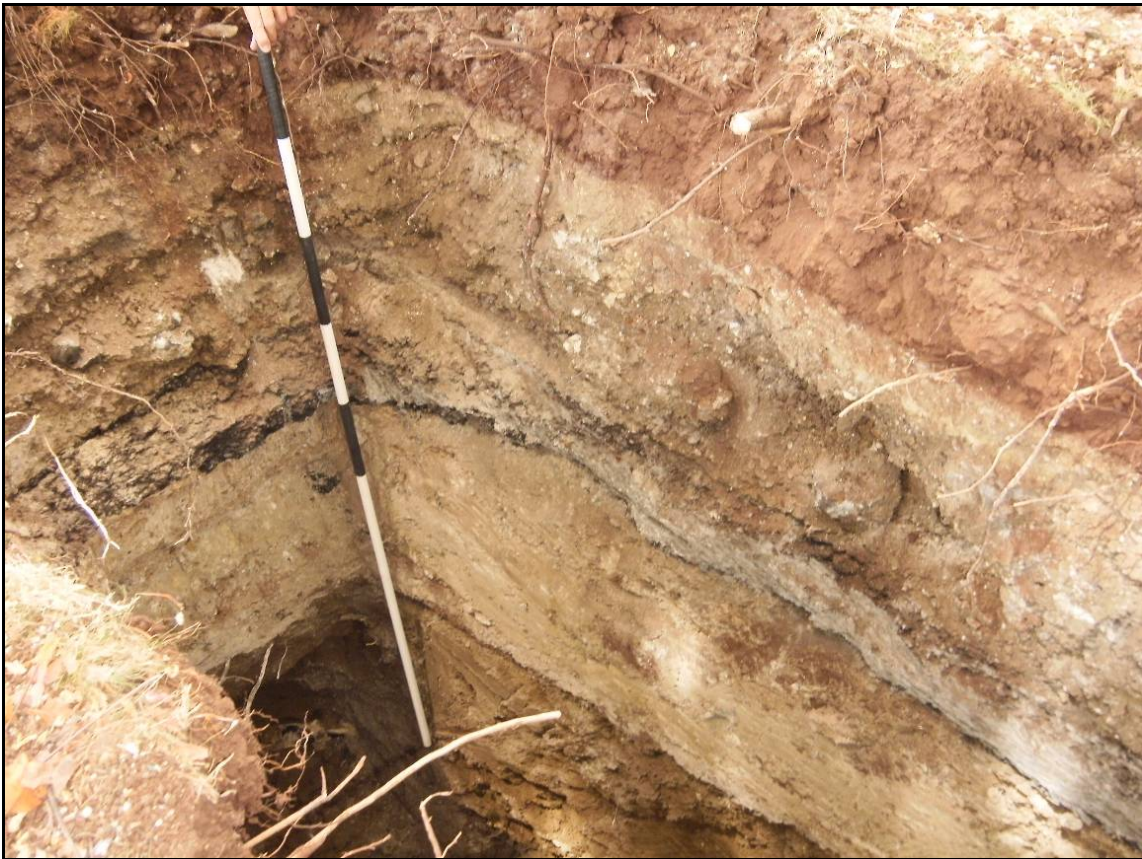
Feature Discussion: The buried asphalt pavement (Stratum IIa) and associated crushed coral base course (Stratum IIb) were designated as SIHP # 50-80-13-7420 Feature 2. The buried asphalt and base course extended beyond the limits of the excavation area. Strata IIa and IIb were interpreted as a former mid-twentieth century road (see Section 7.4.2 below).

Figure 158. Photograph of Airport Section 3, T-017, general view of profile, view to north

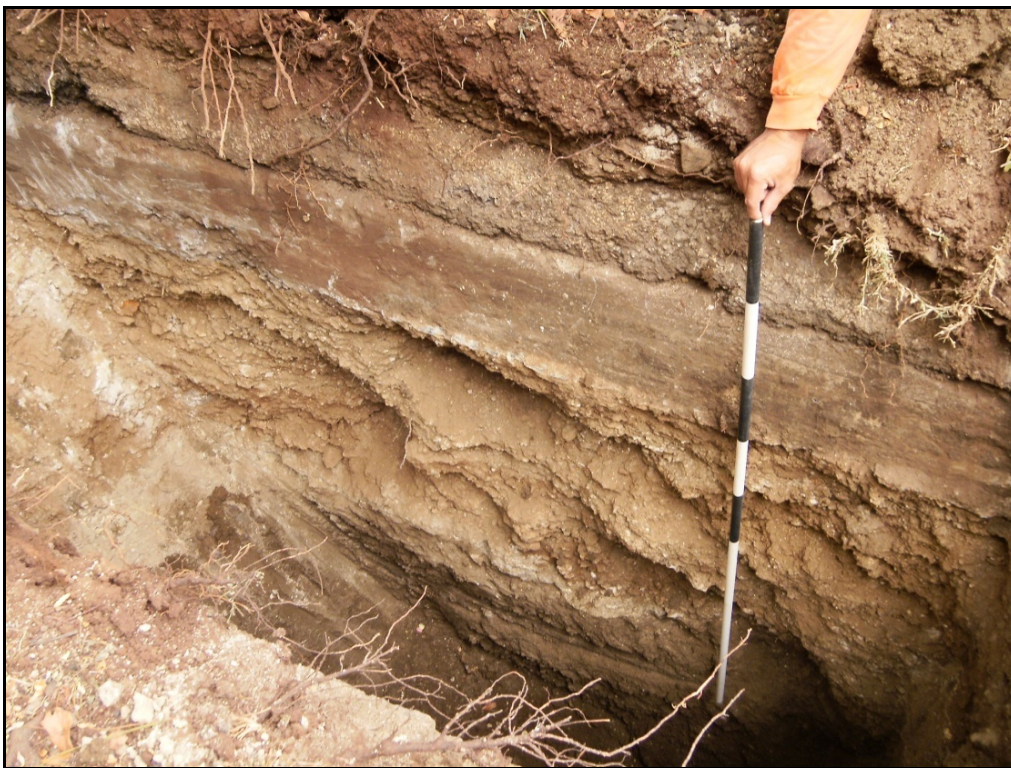
Stratigraphic Summary: The stratigraphy consisted of fill strata over natural sediment (Figure 161 and Figure 162). Observed strata were topsoil fill (Stratum Ia), gravelly sandy loam fill (Stratum Ib), buried asphalt pavement (Stratum IIa), buried concrete curbing (Stratum IIb), and crushed coral base course (Stratum IIc) overlying natural clay (Stratum III) and volcanic tuff (Stratum IV). The stratigraphy conformed to the USDA soil designation of Makalapa clay (MdB) for this location.

Figure 161. Photograph of Airport Section 3, T-018, general view of profile, view to southeast

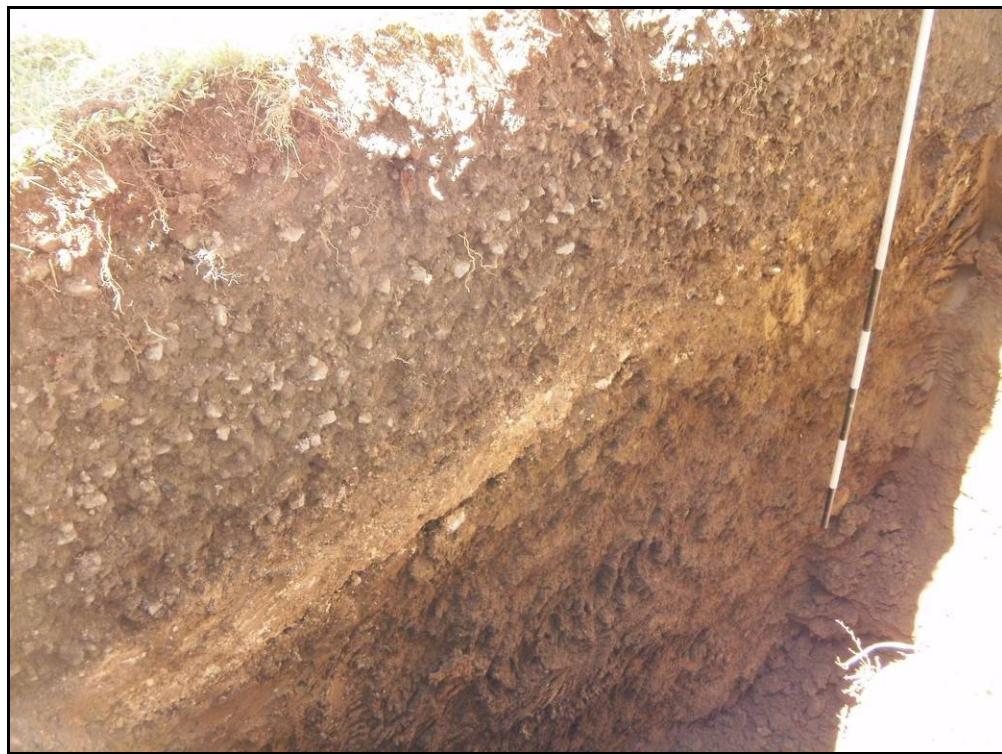
Stratigraphic Summary: The stratigraphy of T-019 consisted of fill strata over natural sediment (Figure 164 and Figure 165). Observed strata were topsoil fill (Stratum Ia), extremely gravelly loam fill (Stratum Ib), crushed coral fill (Stratum Ic), and crushed asphalt fill (Id) overlying natural clay (Stratum II). The stratigraphy conformed to the USDA soil survey designation of Makalapa clay (MdB) for this location.

Figure 164. Photograph of Airport Section 3, T-019, general view of profile, view to northwest

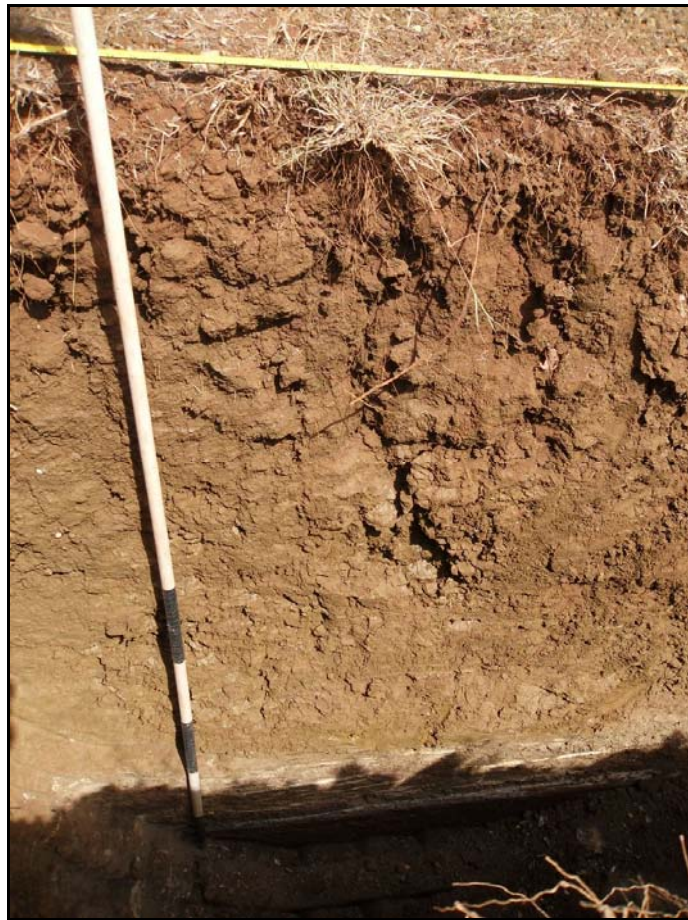
Stratigraphic Summary: The stratigraphy consisted of fill strata over natural sediment (Figure 167 and Figure 168). Observed strata were silty clay fill (Stratum Ia), extremely gravelly loam fill (Stratum Ib), and sandy clay fill (Stratum Ic) overlying natural silty clay (Stratum II) and volcanic tuff and ash (Stratum IIIa and IIIb). The stratigraphy generally conformed to the USDA soil survey designation of Makalapa Clay (MdB) for this location.

Figure 167. Photograph of Airport Section 3, T-020, general view of profile, view to north

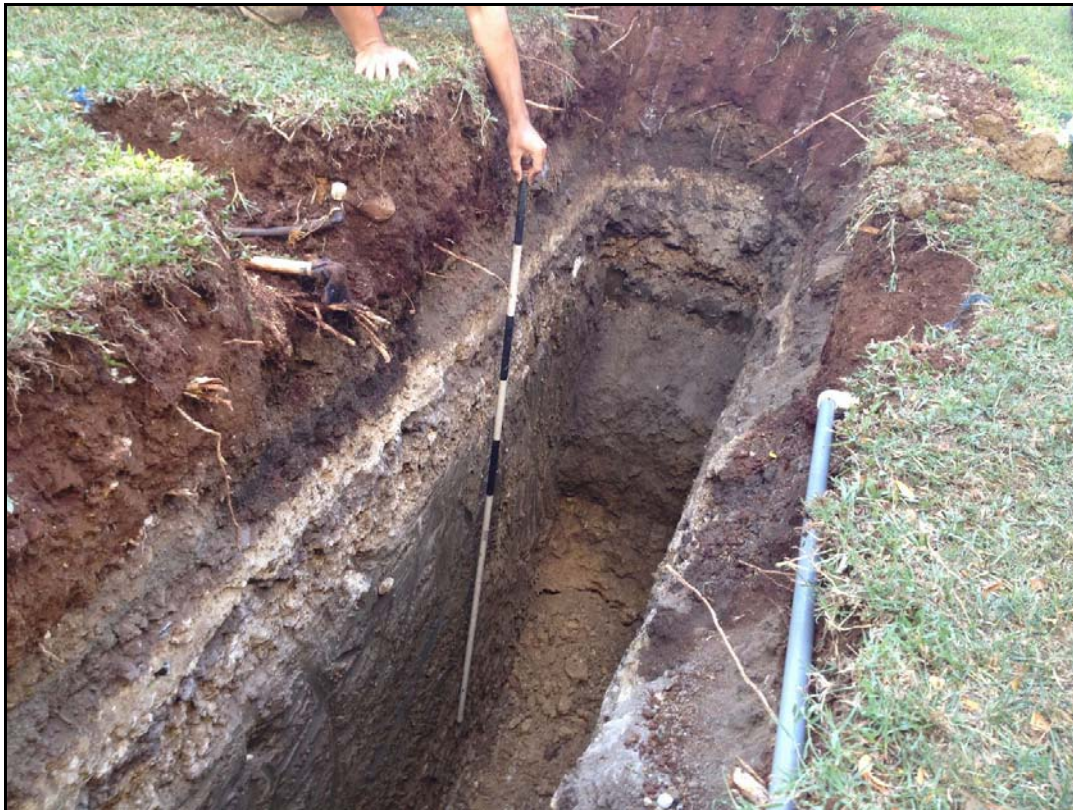
Stratigraphic Summary: The stratigraphy of T-021 consisted of fill strata over natural sediment (Figure 170 and Figure 171). Observed strata were silty clay loam topsoil (Stratum Ia), very gravelly silty sand fill (Stratum Ib), compacted coral pavement (Stratum IIa), and crushed coral base course (Stratum IIb) overlying natural clay (Stratum III) and the coral shelf (Stratum IV). The fill deposits correlate with airport development. The stratigraphy above Stratum III generally conformed to the USDA soil survey designation of Fill land (FL).

Figure 170. Photograph of Airport Section 3, T-021, general view of profile, view to southeast

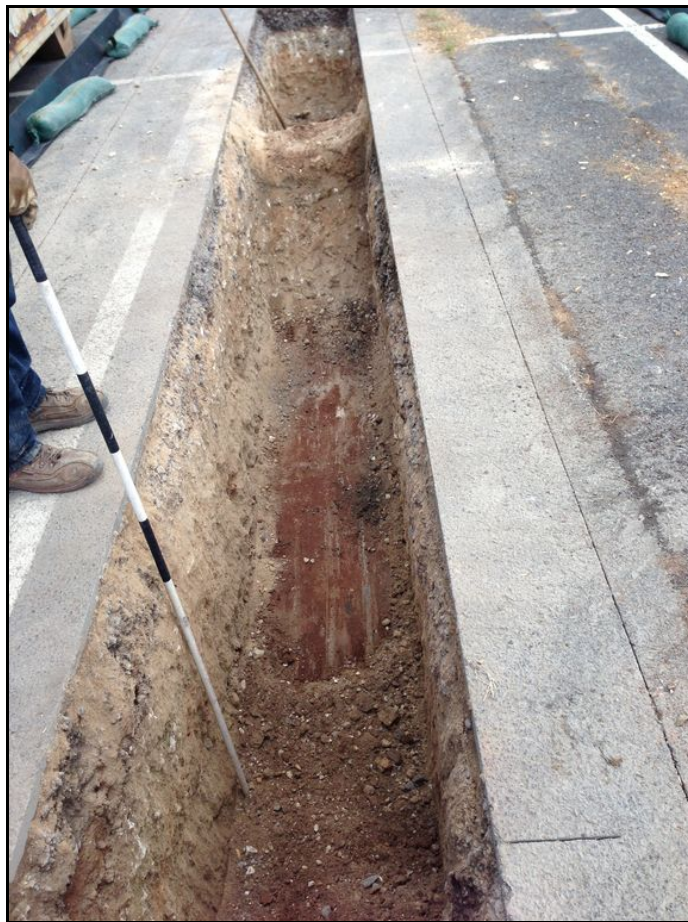
Documentation Limitations: T-023 was excavated to a buried concrete slab at a depth of 1.20 mbs. A concrete jacket and two PVC utility lines limited excavation in the central portion of T-023. Excavation through the concrete slab was not conducted due to potential sidewall instability and to adversely affecting the encased utility lines.

Stratigraphic Summary: The stratigraphy of T-023 consisted of fill strata over a buried concrete slab (Figure 177 and Figure 178). Observed strata were asphalt (Stratum Ia), basalt base course (Stratum Ib), gravelly loam fill (Stratum Ic), very gravelly cobbly silty sand fill (Stratum Id), gravelly sand fill (Stratum Ie), and gravelly silty sand fill (Stratum If) overlying a buried concrete slab (Stratum II). The observed stratigraphy of T-023 conformed to the USDA soil survey designation of Fill land (FL).

Figure 177. Photograph of Airport Section 3, T-023, general view of west profile, view to north
